*The Storebælt Link - a geotechnical view*

Steenfelt, J. S.; Hansen, H. K.

The Interplay between Geotechnical Engineering and Engineering Geology : Proceedings of the Eleventh European Conference on Soil Mechanics and Foundation Engineering, Copenhagen, 28 May - 1 June 1995 : XI ECSMFE E

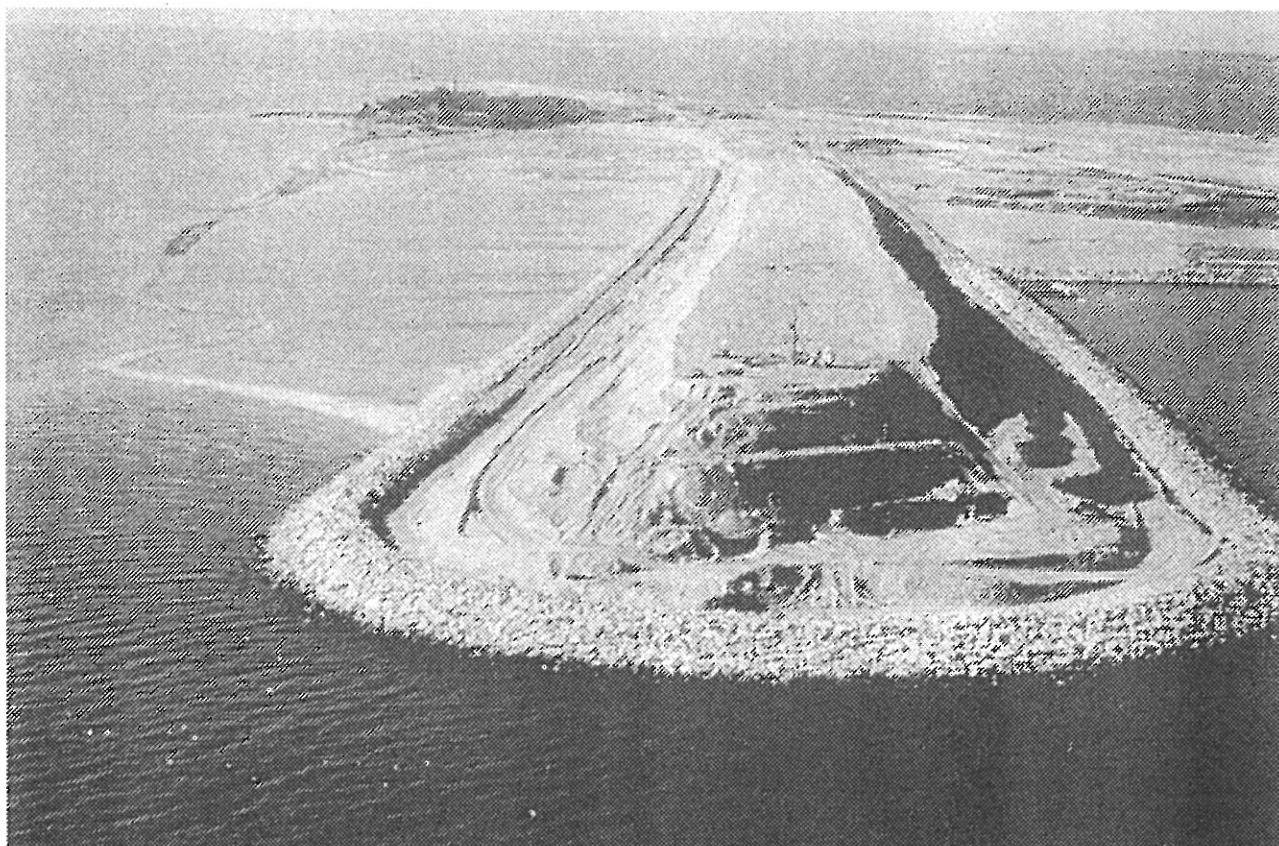
Fig. 22. DGI mobile drilling rig at top of embankment for East Bridge approach ramp on Sprogø

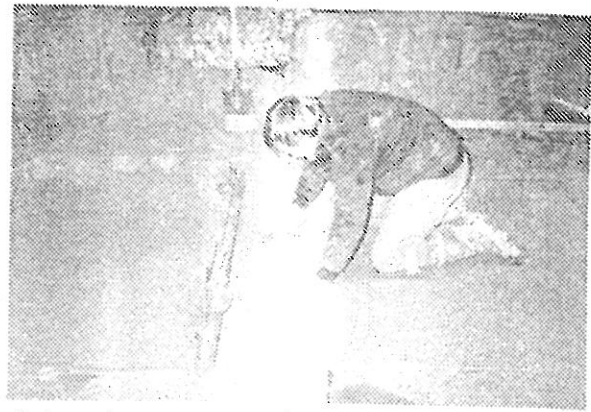
Fig. 36 Preparation of test surface of intact clay till. (a) grab-excavator; (b) finish by hand tools

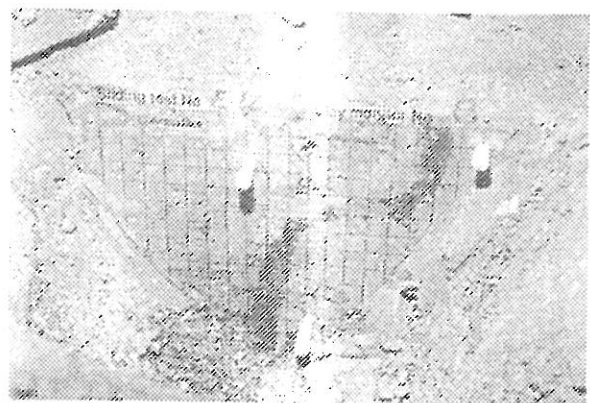
Fig. 38 Coloured clay marker exposed after test (on the 10 mm grid the sliding surface is seen some 50-60 mm below the surface)

The displacements in the potentially affected clay till zone were monitored by initially vertical tell-tale holes drilled into the clay till and filled with markers at the top of the clay till (Figure 37) and washers or coloured clay (Figure 38, showing special transparent sheets for easy recording of failure patterns).
